AUWA was hired by Stanley Consultants of Tampa Florida to conduct an underwater investigation of the downstream dam apron of the Coon Rapids dam in Coon Rapids Minnesota. The investigation was conducted from November 22- 25, 2009.

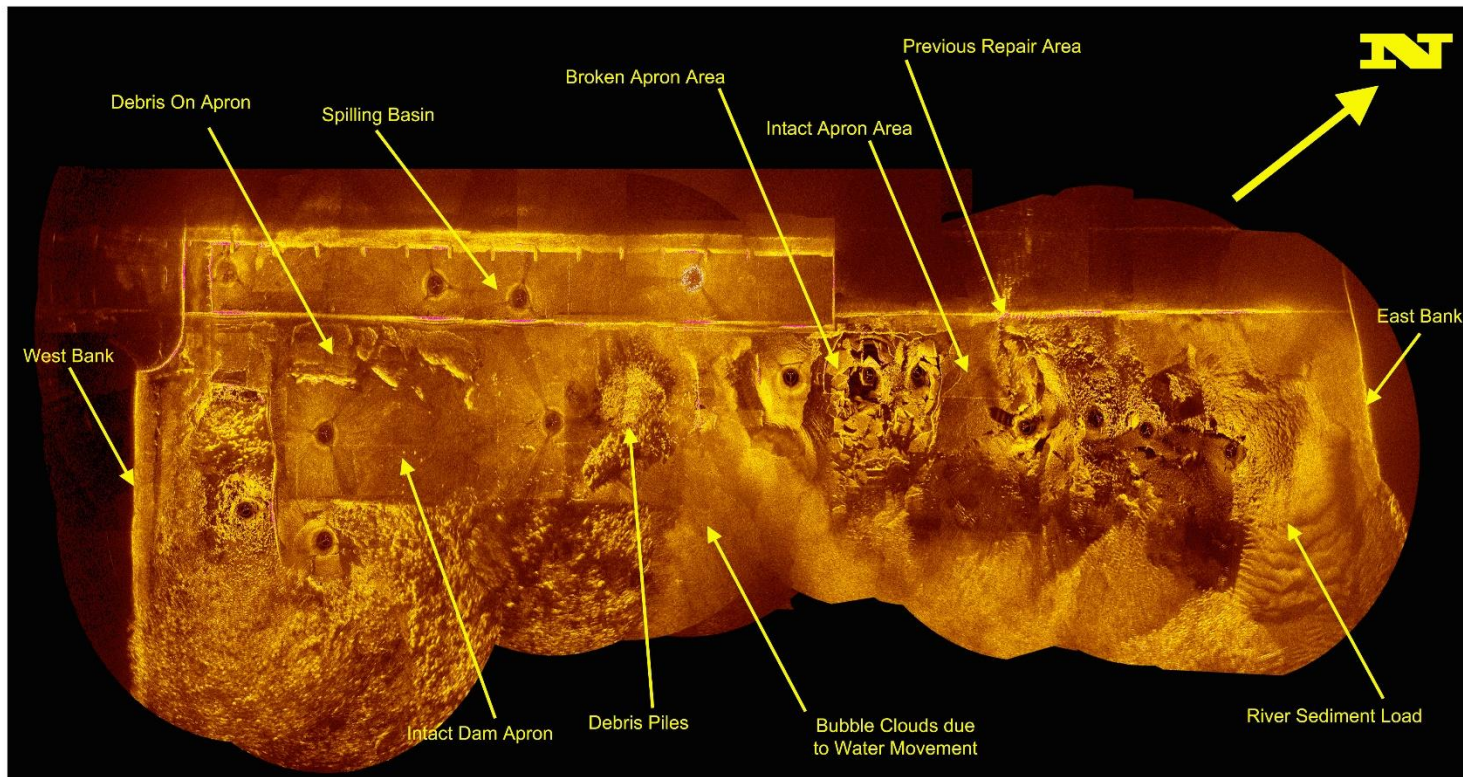
FIGURE # 1
Plan View of the Coon Rapids Dam Apron
Coon Rapids, Minnesota

AUWA as able to identify all structural defects with the dam apron and the amount of sediment load on the dam apron. NMGI identified an area 120 feet X 150 feet that has structurally failed. The failure has caused the dam apron to become under mined.

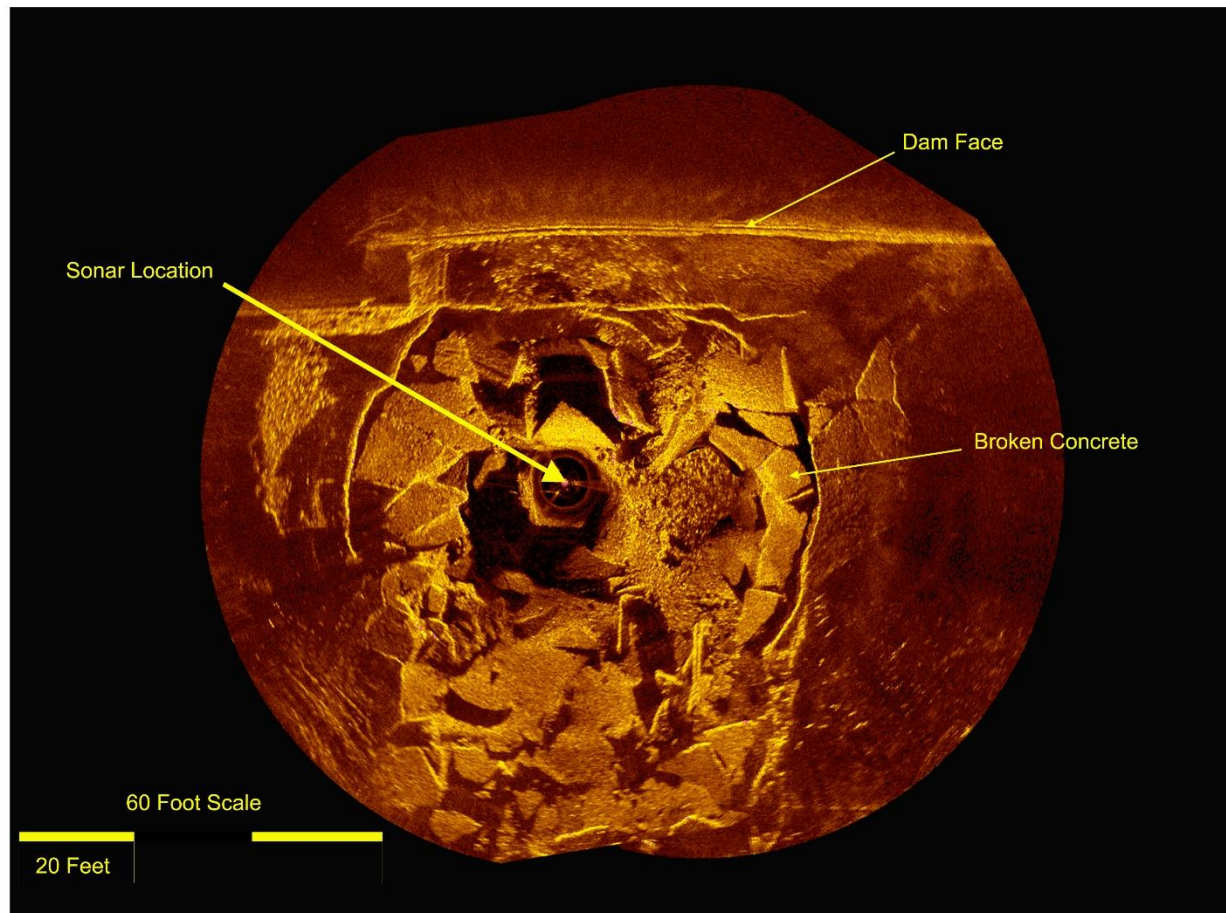
FIGURE # 2
Broken Apron Area of the Coon Rapids Dams
Coon Rapids, Minnesota

The second component of the project was to image the scour hole under the dam apron and to determine the relative size of the undermined scour hole. The MS 1000 was placed in a previously known under mined location of the dam apron by a surface supplied air diver. In this scour hole two types of images were conducted i.e. plan view and vertical view. Imaging ranges of 22.5 to 45 feet were used to determine the size of the hole.
